# Manhole Inspection Summary

Manhole # S41II\_039MH

Insp Date: **6/9/09 9:19 AM**

**Location** Address: **1541 CAROLINE ST**

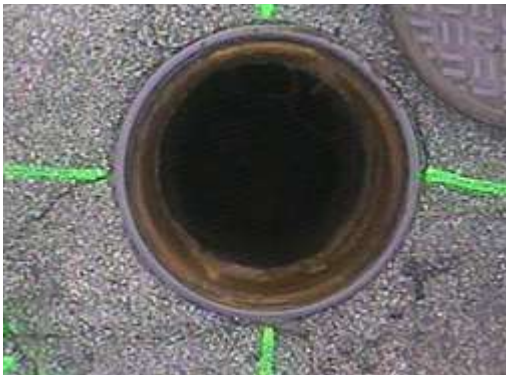
Defect 2

Offset: **1** (in.)

frame offset

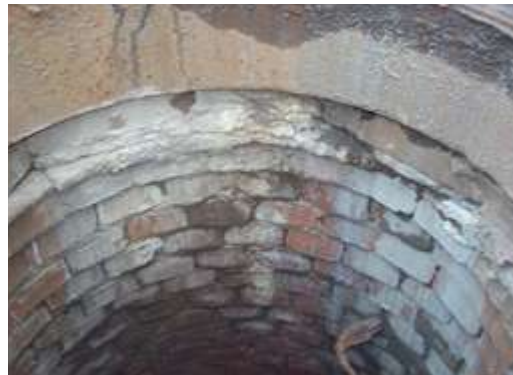
Defect 1

Condition: ☐ Sound ☒ **Cracked** ☐ Root Intrusion ☐ Loose Brick ☐ Deteriorated

Count: **8** Missing: **1** ☒ **Corroded**

Cracked chimney and corroded steps

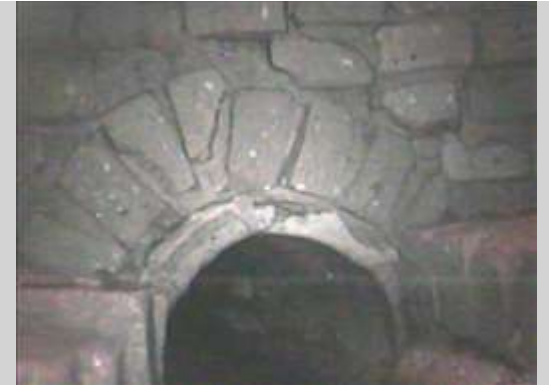
12 O'Clock Outflow

10 in. Circular Gravity Sewer  
Pipe Out @ 12 O'Clock

Pipe Height: (in.) Direct  
Pipe Material: **Clay** ☐ Pipe Lined  
Invert Depth: **13.90** (ft.) Flow Characteristics: **Fast**  
Deposits: ☒ None ☐ Mud ☐ Sludge ☐ Debris ☐ Grease  
Silt Depth: (in.) Deposits Extent:  
Infiltration: **None** Pipe Seal Cond: **Sound**

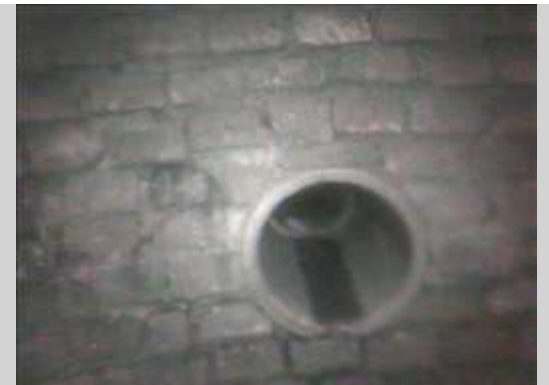
3 O'Clock Inflow

8 in. Circular Gravity Sewer  
Pipe In @ 3 O'Clock

Pipe Height: (in.) Direct  
Pipe Material: **Clay** ☐ Pipe Lined  
Invert Depth: **10.55** (ft.) Flow Characteristics: **Slow**  
Deposits: ☒ None ☐ Mud ☐ Sludge ☐ Debris ☐ Grease  
Silt Depth: (in.) Deposits Extent:  
Infiltration: **None** Pipe Seal Cond: **Sound**

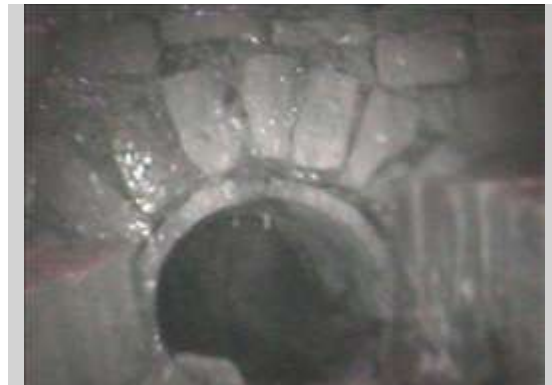
Drop In @ 3 O'Clock

Drop: **Outside Direct**  
Angled: Reading: (ft.)  
Inv Depth: **13.71** (ft.)  
Drop Condition: **Partly Clogged**

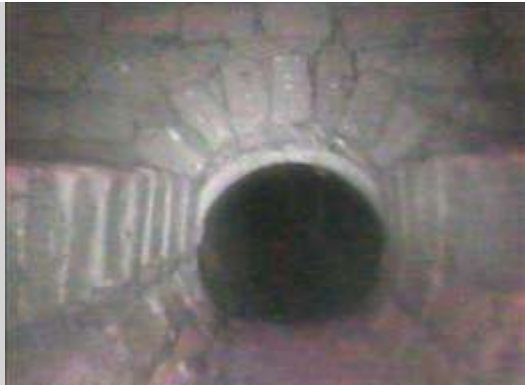
6 O'Clock Inflow

Infiltration: **None** Pipe Seal Cond: **Sound**

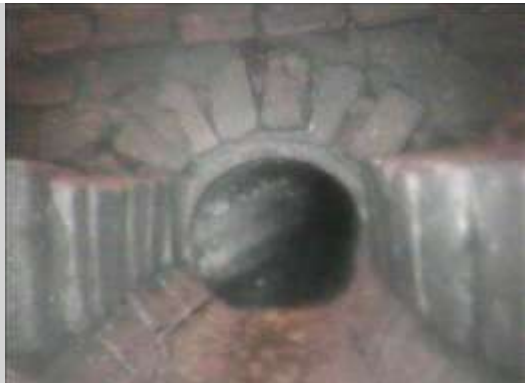
9 O'Clock Inflow

Infiltration: **None** Pipe Seal Cond: **Sound**
